Subject Drilling Equipment, Contractor Bissell

In relation to contract No. 424043804 of Direct Award, formalized between the contractor BISSELL Construcciones e Ingeniería, S.A de C.V. and Pemex Exploración y Producción, for the execution of the "Integral Works for Onshore Well Interventions in the Northern Region (Package 1) of Direct Award"; I hereby inform you the following:

Therefore, on August 14, 2013, a visit was made to the rehabilitation workshops of the aforementioned contractor, located on Highway 180 Poza Rica - Tuxpan (Poza Rica - Tihuatlan section, Rancho Santa Elena lot 32 and 33 "Zapotalillo", where missing equipment was observed, dismantled, as shown in the following photographs:

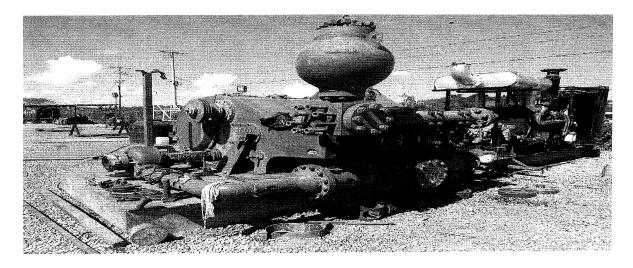
• Sludge pump. -Lack of coupling with the motor as well as tightening of connections and belts.

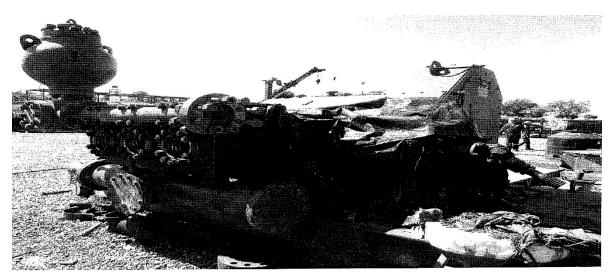
• Sludge pump. -Lack of coupling with the motor as well as tightening of connections and belts.

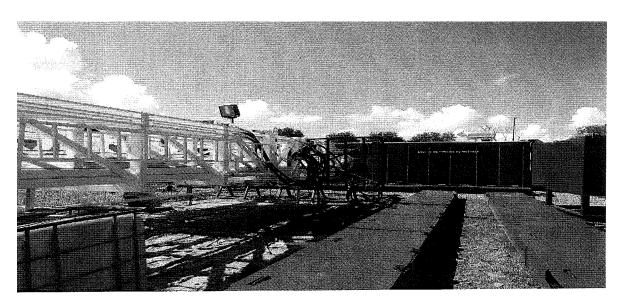
• Equipment Mast: - To be wired, connected and tested.

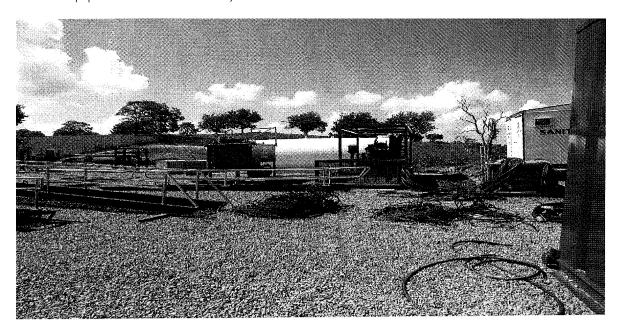
• Bomba Koomey, conexiones faltantes, calibración, instrumentación y pruebas.

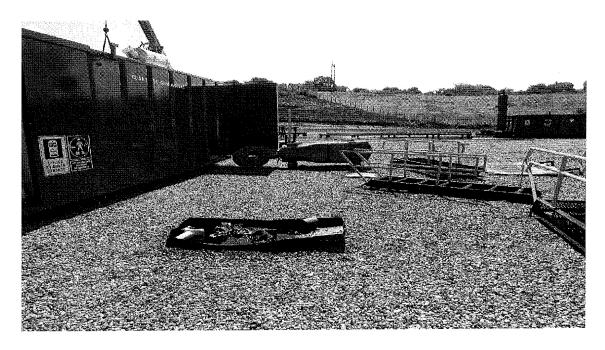
• Traveling Pulley: -Lack of installation, wiring.

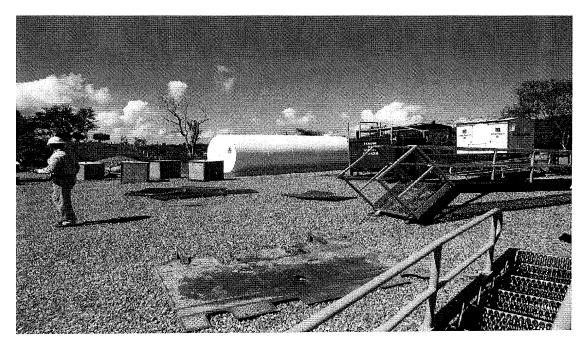
• Vacuum tank missing tests.

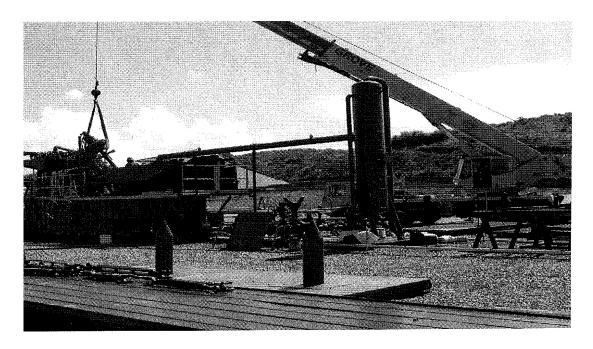
• Sludge dams, agitation dams and gas-sludge separators: - Lack of connections, gaskets.

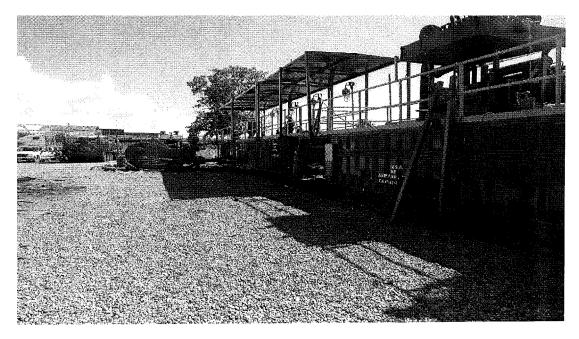
• Pumps and sludge dams: - lack of installation of bottom guns General tests.

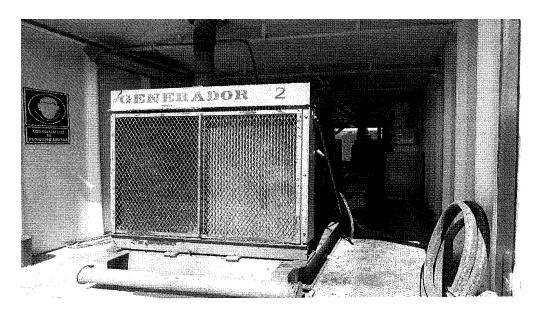
• Generator: - Lack of general connections, lack of another air compressor.

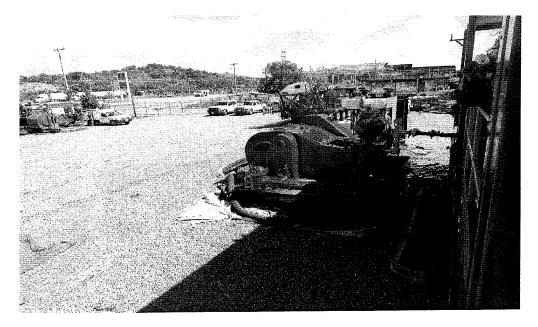
• Sludge Pump: - Missing connections, packaging and tests.
