Appraisal Report - -----

File No. 06-001362-0163-CA - -----

Report on the review of the Administrative Appraisal AA-110-2006, performed by the Ministry of Finance, on the date of September 22nd of 2006 and that performed by Eng. Franklin Sandí Lizano in February of

Location of the land-strip for the expropriation process of the property of Vacation Rentals Sociedad Anónima (Corporation), for the consolidation of the National Marine Park Las Baulas in the Eighth District of Cabo Velas, Third Canton Santa Crua, Fifth Province of Guanacaste. -----

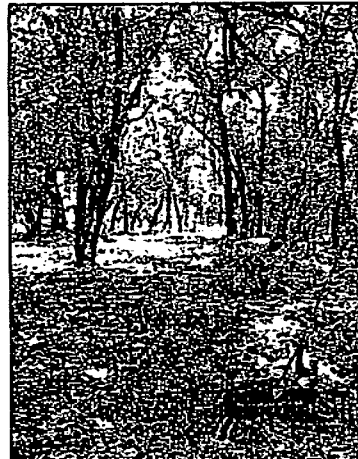
Foto 3- Servidumbre de paso, y cajas reg. viejas, 10/11/09, R.B.

Se ubica a 2.743 metros desde la casa del guarda parques, sobre camino de tierra y lastre, los últimos 200 metros sobre una servidumbre de acceso inconclusa y no habilitada, sobre la cual se detectaron cajas de registro y cables altamente deteriorados.

Cajas registro destruidas sobre servidumbre no habilitada

Su uso pretendido es aparentemente habitacional, como acceso cuenta con una servidumbre establecida legalmente pero no habilitada, presentando limitaciones que afectan seriamente su valoración por no contar la *infraestructura necesaria de servicios requeridos: calles, aceras, cordón y caño, tuberías de agua potable, electricidad y teléfono, cableados para estos servicios, etc (ver fotos 3 y 4).*

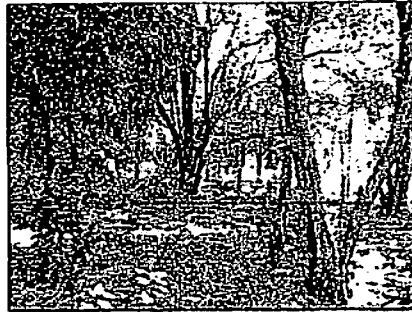
Foto 6-Bosque Secundario limitado al Este desde limite 125 m, 10/11/09, R.B.

Su vista hacia la zona marina está afectada por el bosque mencionado impidiendo su visión panorámica al mar.

- La zona frontal de la propiedad, al este de los 125 metros que delimitan las restricciones del Parque Nacional Marino Las Baulas, con un frente de 39.13 m y un fondo estimado de 122 m, constituye la zona este del inmueble o remanente para el propietario y no tiene afectaciones, por tanto su coeficiente de afectación es de 1.0 (ver figura 2 y Foto 6).

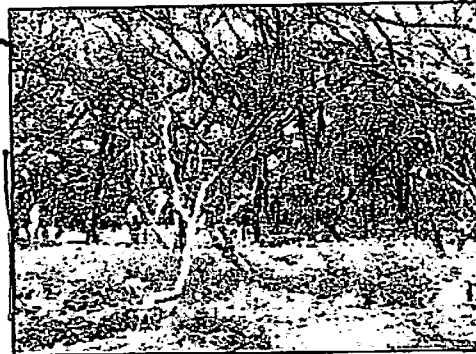
Foto 9-Zona Oeste desde 50m de playa, 10/11/09, R.B.

afectación es 0.3 (en otras palabras pierde el 70% de su valor por las restricciones impuestas, ver figura 2 y Foto 9).

Entiéndase que estas limitaciones indicadas constituyen afectación ya existentes del valor de esa banda del inmueble desde 1995 y permanecen expripiase o no la faja de terreno.
